SUMMARY REPORT

Redefined Spaces Home Inspections
415 Fair meadow Lane
Elkhorn, WI 53121
Ph. #: (262) 424-4839

Dwelling Address: W1117 Keefe Rd.
Elkhorn WI 53121

Inspector: James Smead

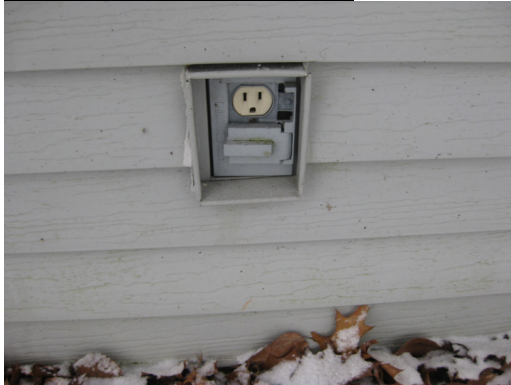
54. Electric/Outlets

**The outlet isn't properly grounded and is missing a cover
recommend a qualified electrician repair.**

| 54. | Electric/Outlets | Outlet. The outlet isn't properly grounded and is missing a cover recommend a qualified electrician repair. |

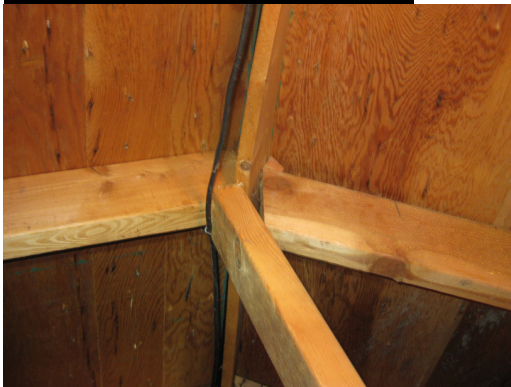
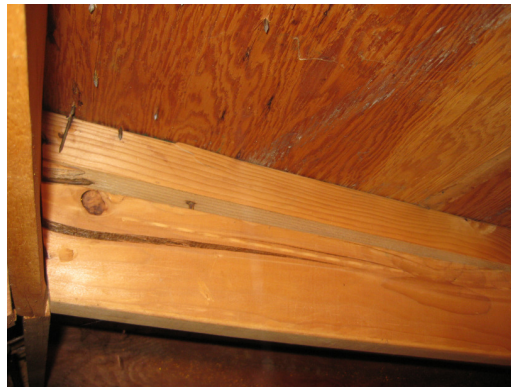
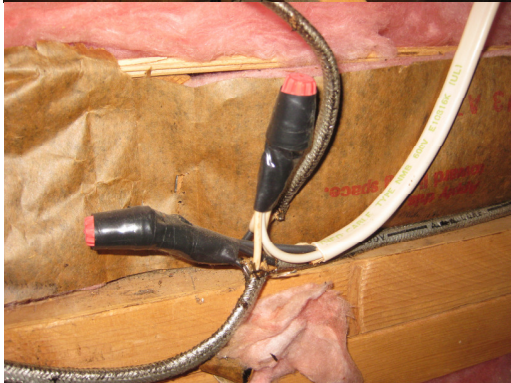
The ridge boards have moved and cracked recommend further evaluation and repair by a qualified contractor.

Splices in electrical wiring should be properly encased in junction box. Open junction boxes should be properly covered.

| 22. | Structure | Stick built. The ridge boards have moved and cracked recommend further evaluation and repair by a qualified contractor. |
| 26. | Electrical Conditions | Open junction box (es); open splice(s). Splices in electrical wiring should be properly encased in junction box. Open junction boxes should be properly covered. |

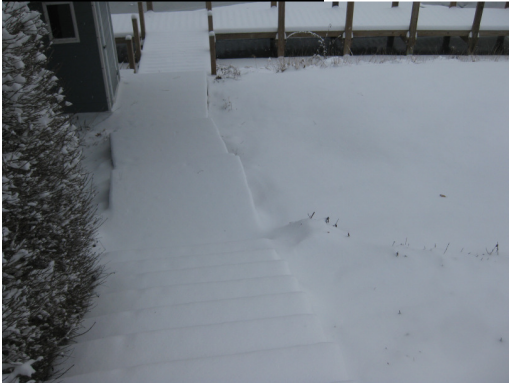
43. Deck

The stairs going down to the deck should have a railing recommend a qualified contractor repair.

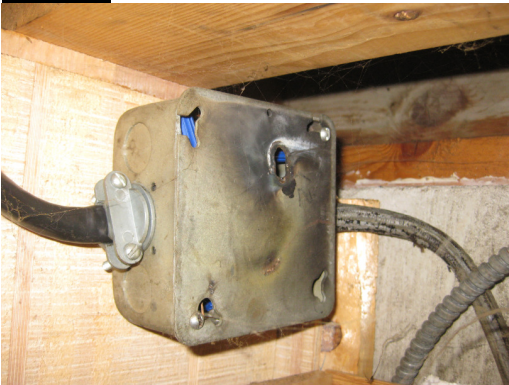
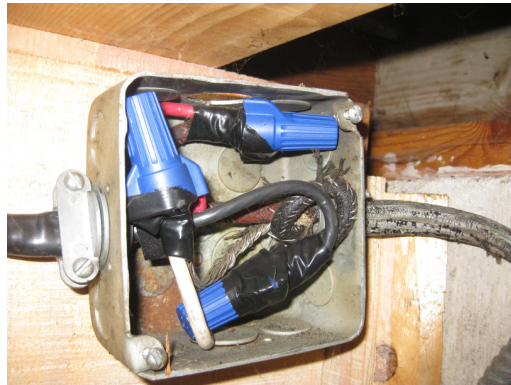
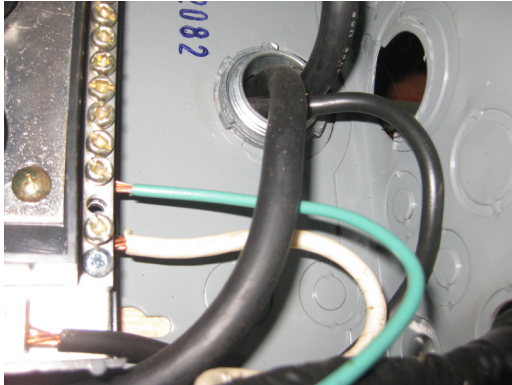
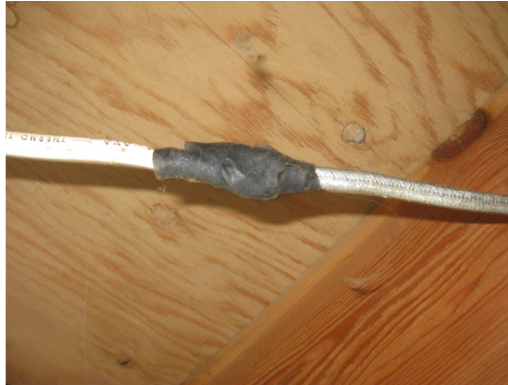
The wires that power the stove go to a junction box above the drop ceiling. The box cover appears to have been burnt in addition the ground wire isn't grounded to ten box. In addition the subpanel next to the junction box isn't properly grounded recommend a qualified electrician evaluate and repair.

The outlets are not grounded recommend a qualified contractor repair any outlets that are near a water source.

Panel & drop ceilings. There are many boxes without covers and open splices that are not properly terminated in a box recommend a qualified electrician repair.

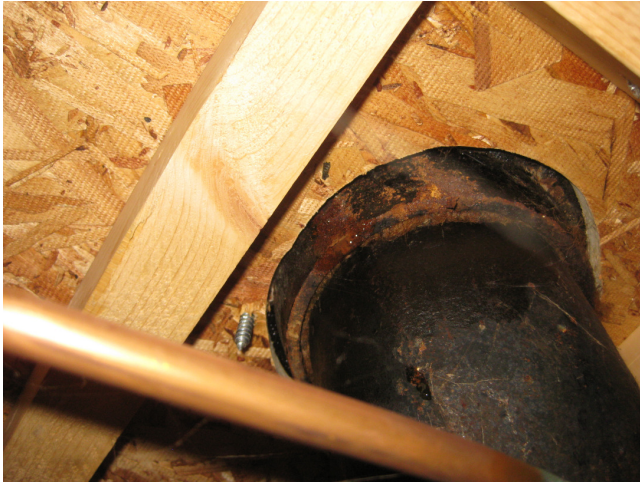
103.2. Fixtures-Toilet

The toilet is very loose and is leaking recommend a qualified contractor repair.

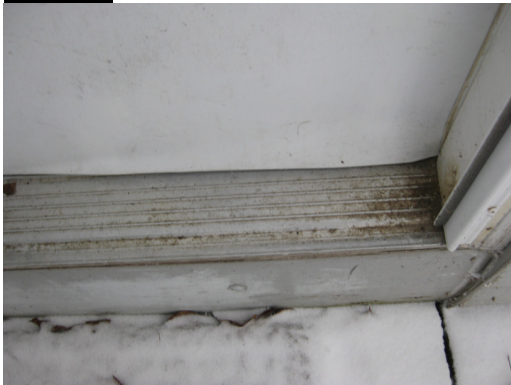
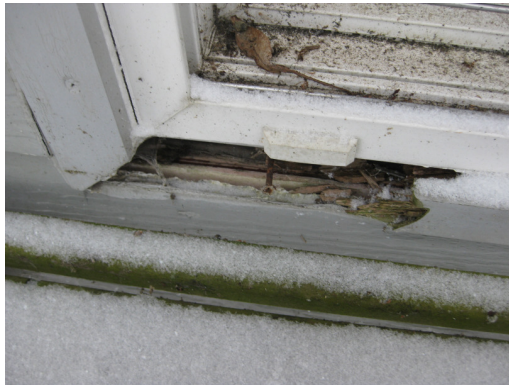
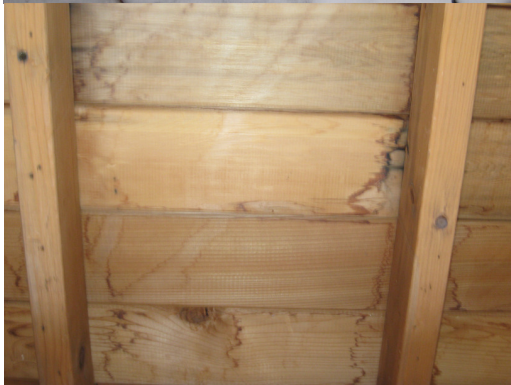
The front door is dented on the bottom and sticks when

trying to open in addition the patio doors have damaged trim, recommend a qualified contractor repair

The North wall at the bottom is moved in from the top recommend a qualified contractor evaluate and repair.

There are moisture stains above the patio door in the living room. When tested with a moisture meter no moisture was found.

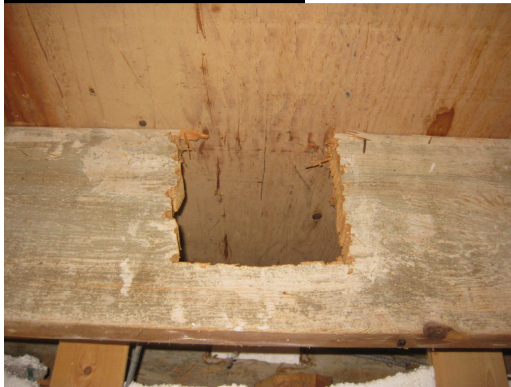
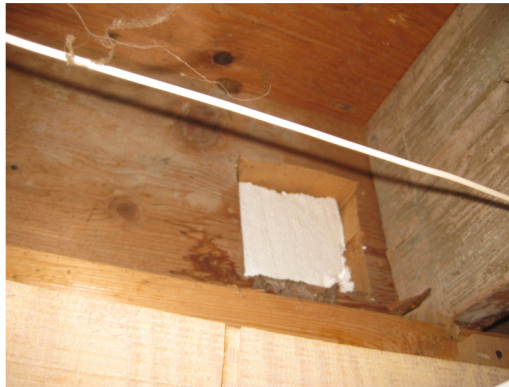
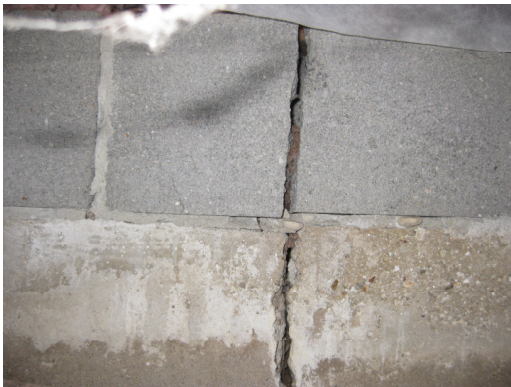
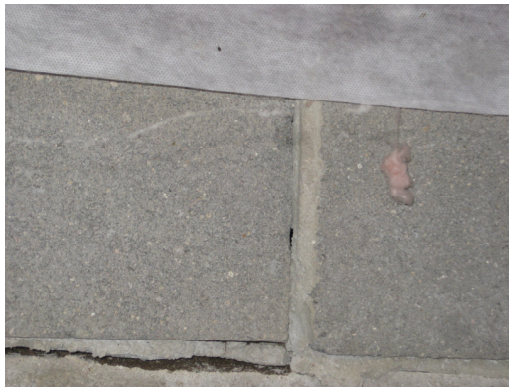
Many of the joists have been cut recommend a qualified contractor evaluate and repair.

The poured concrete and block on the Northside of the building is cracked in many areas and the concrete is starting to slope in towards the home recommend a qualified contractor evaluate further.

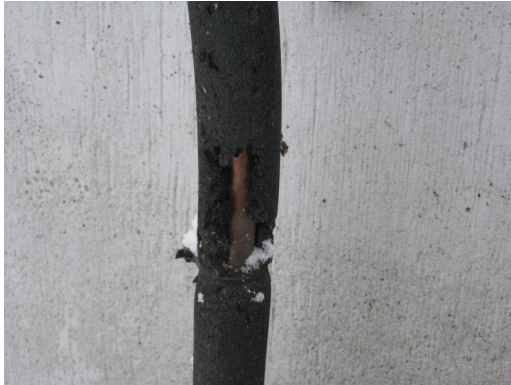
89. Cooling System

The unit is not level and the insulation on the condensate line is worn recommend a qualified contractor repair.

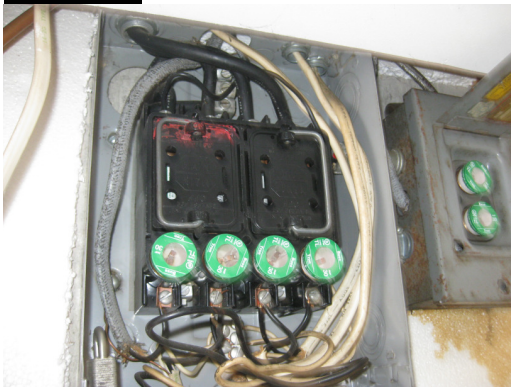
146. Manufacturer

The cover is missing for the panel. It is recommend that you contact your insurance company prior to closing to see if they will cover a fuse type system.

| 146. | Manufacturer | Square-D. The cover is missing for the panel. It is recommend that you contact your insurance company prior to closing to see if they will cover a fuse type system. |

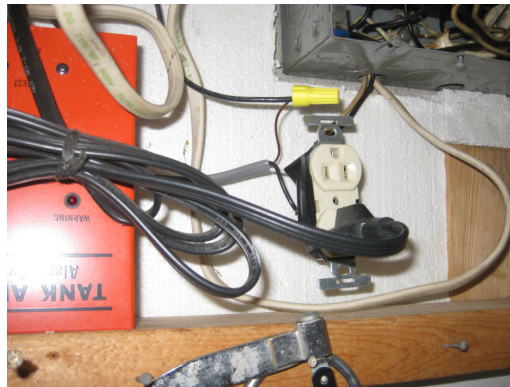
148. Miscellaneous
Defects

All switch/outlet covers should be installed in a box to ensure safety.

| 148. | Miscellaneous Defects | Switch/outlet cover missing. All switch/outlet covers should be installed to ensure safety. |

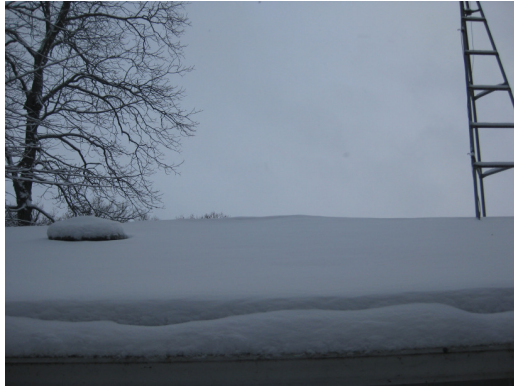
| 30. | Method of Inspection | Viewed from gutter level. The roof is completely covered with snow. |
| 34a. | Observations/Conditions | Unable to determine do to the snow. |
